Development of self-healing carbon fibre reinforced plastic utilising an embedded hollow glass fibre delivery system

**Department of Aerospace Engineering
University of Bristol**

July 2008

**A dissertation submitted to the University of Bristol
In accordance with the requirements of the degree of
Doctor of Philosophy in the Faculty of Engineering**

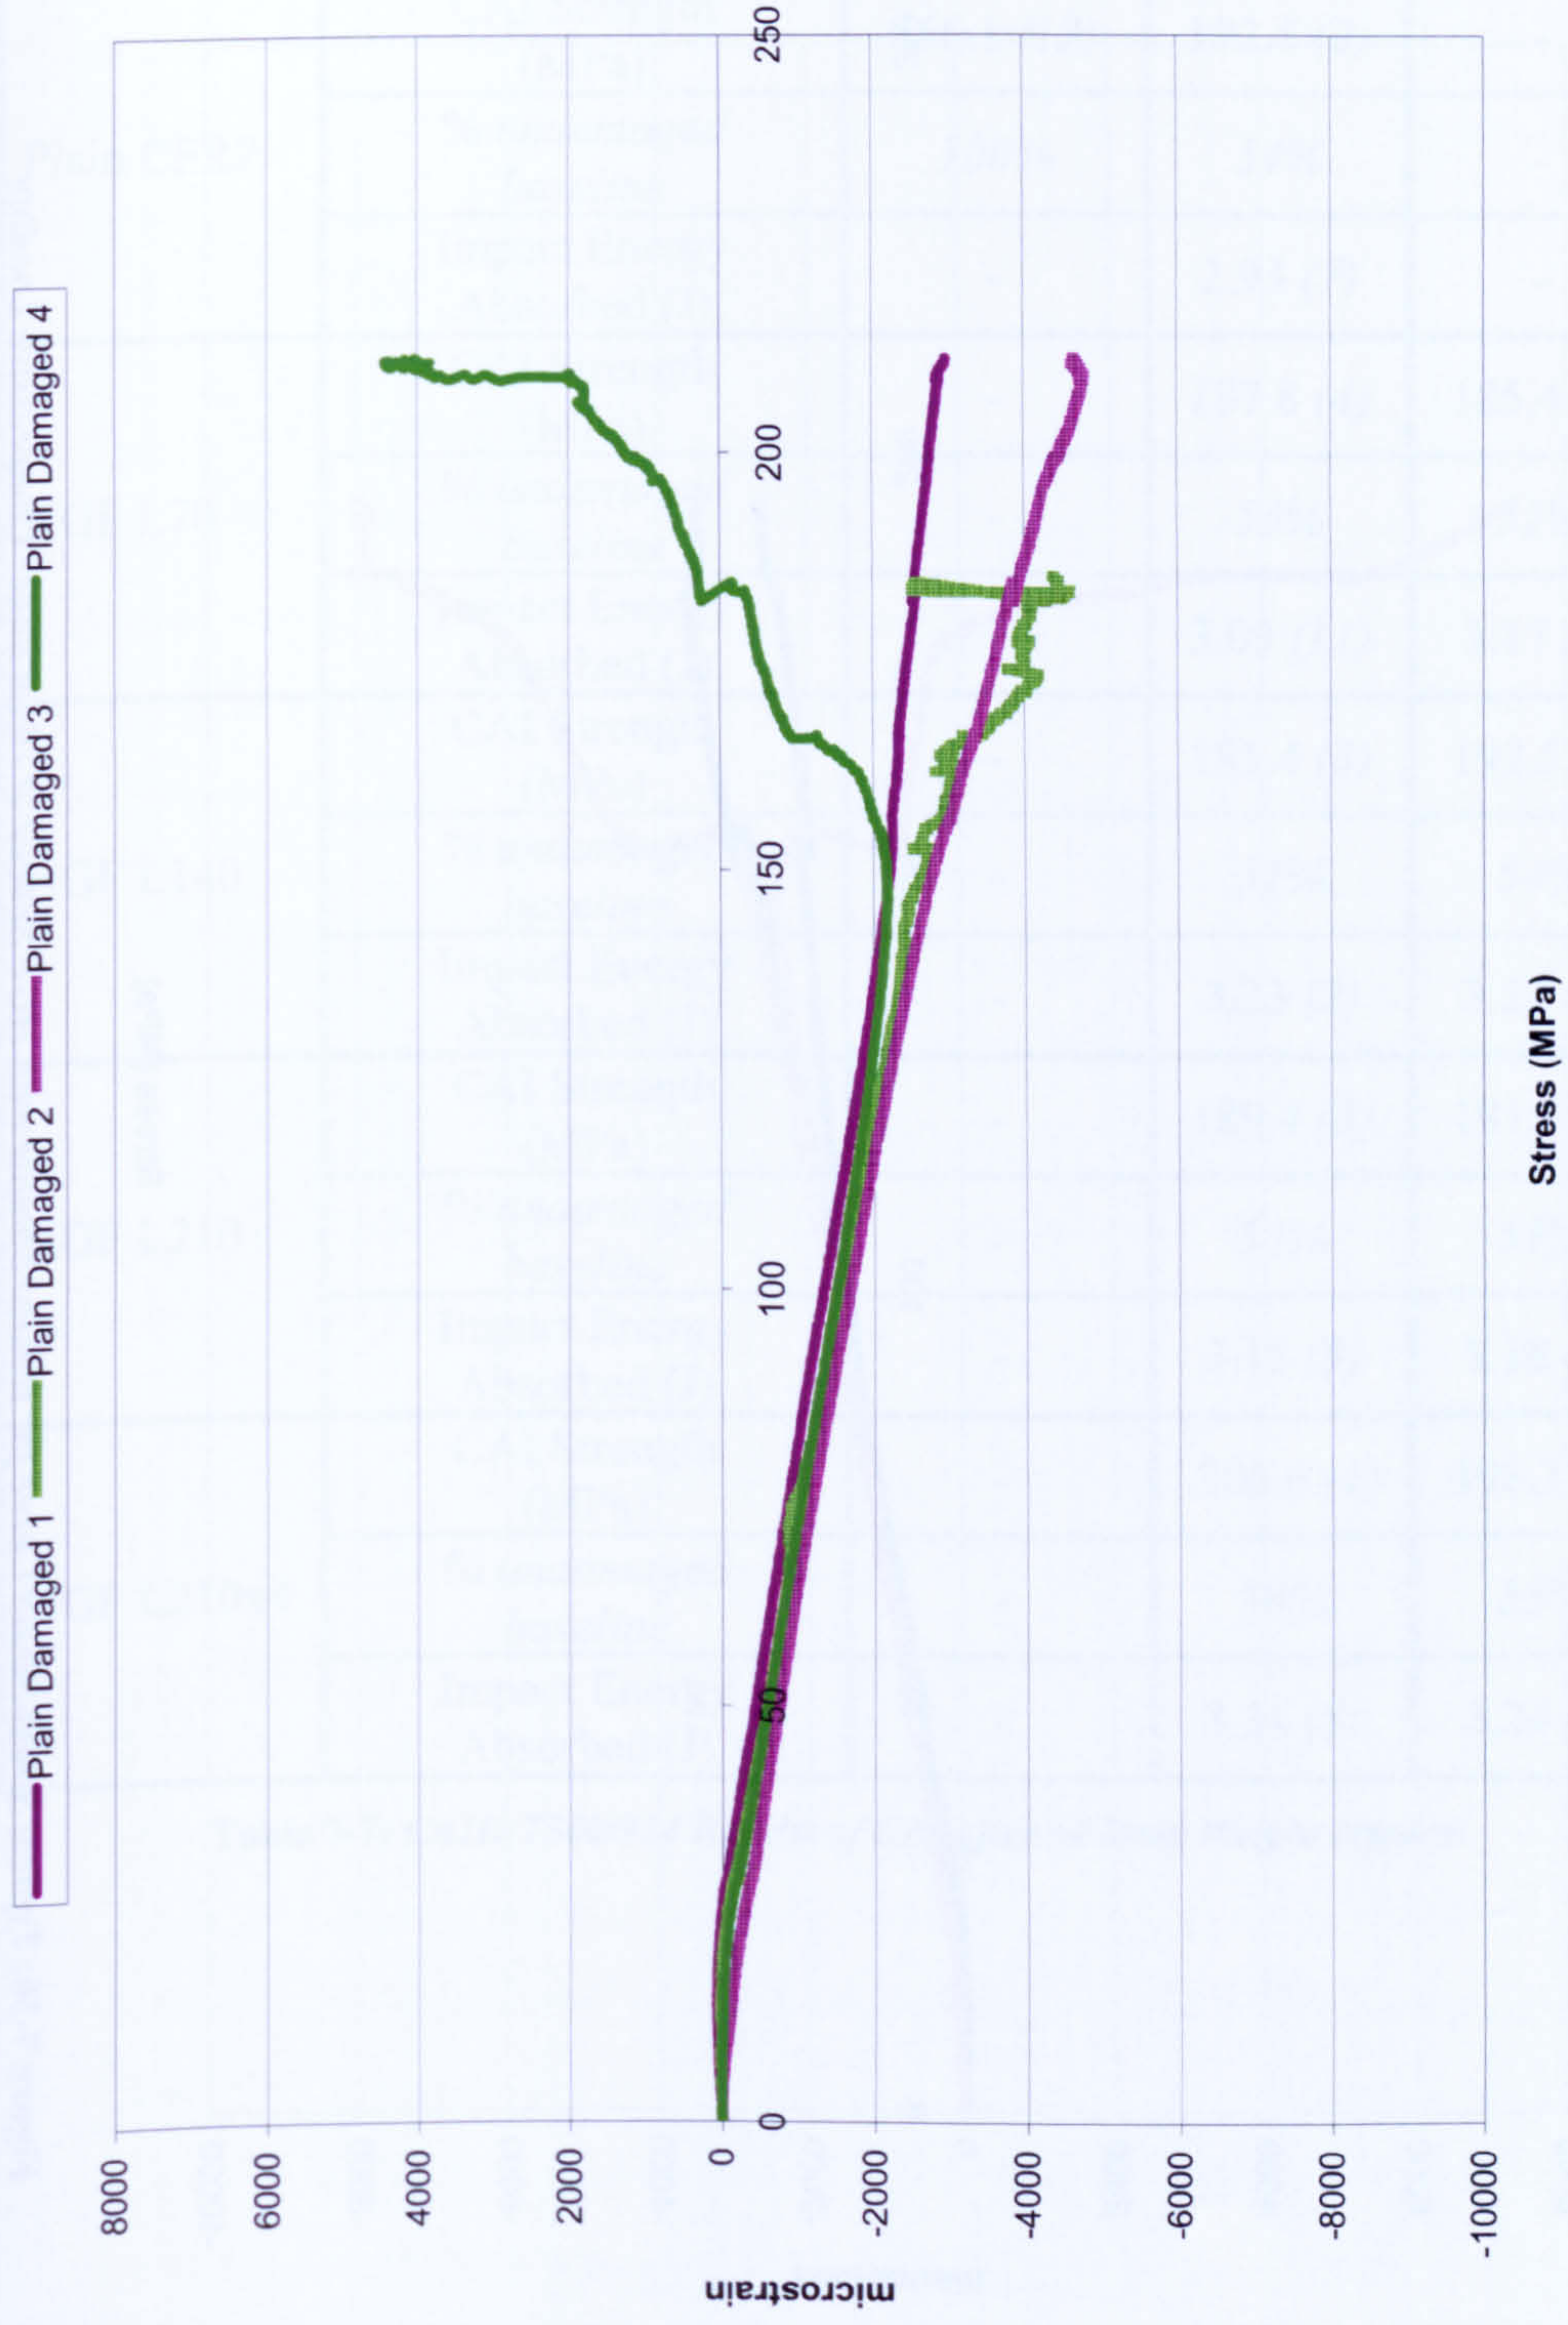
Figure 7-29: Typical Stress-Strain Curve for Damaged Sample with No HGF under Compressive Loading

Typical stress-strain plots are shown in Figure 7-29 and Figure 7-30. It can be seen that the laminates experienced local buckling due to the formation of ‘sub-laminates’ as the delaminations propagated under compressive loading. This divergence is evident when strain gauge pairs (front and back face) are compared. Plots of similar

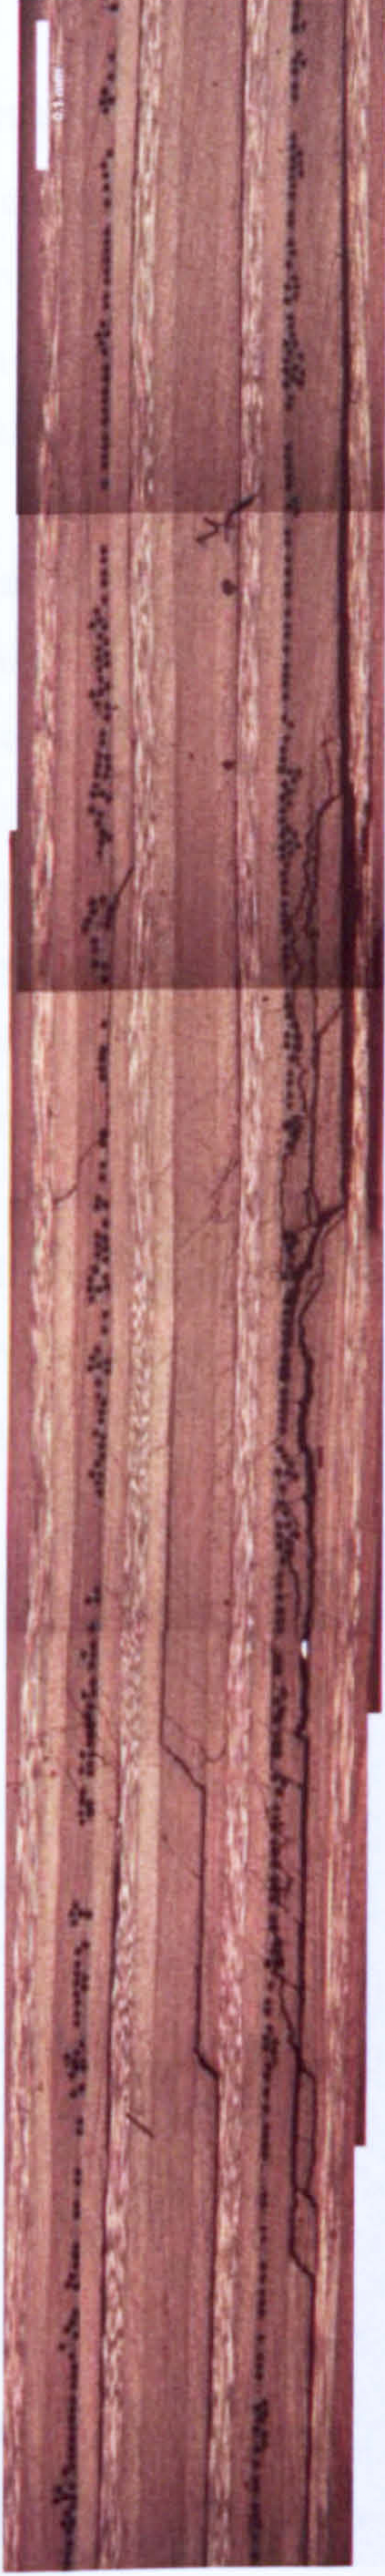
Figure 7-41: Through Thickness Damage Distribution of L_{70} Damaged after 6J Impact

Another possible factor in the laminates inability to heal is evident in Figure 7-41 and Figure 7-42. Here it can be seen that significant damage is present at the back face of the laminates after a 6J impact event. Effectively the laminates are ‘saturated’ with damage which is a consequence of using 6J impact energy with the specified impact boundary conditions. The 40mm impact window outlined in section 2.3 effectively pins the delaminations that would naturally continue extending beyond this boundary if unconstrained. The result is that the impact energy is dissipated by increased

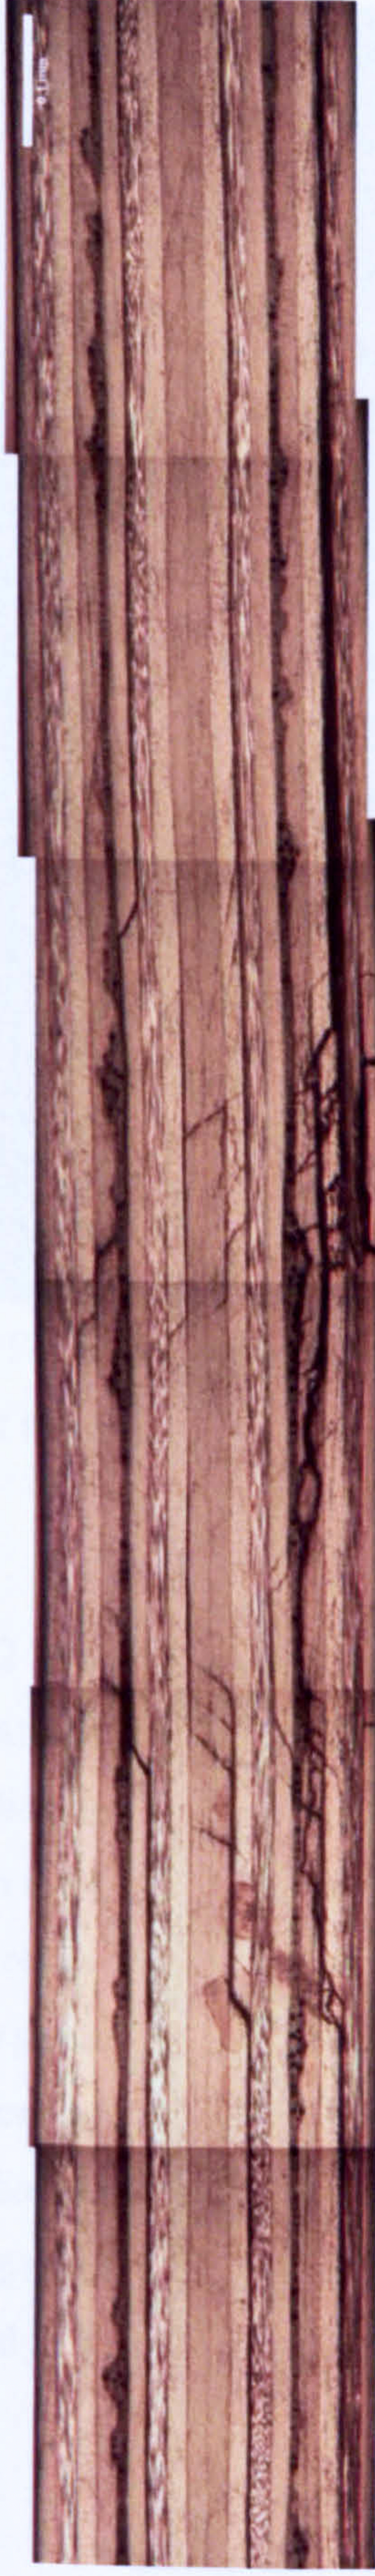
Figure 7-42: Through Thickness Damage Distribution of L_{70} Healed after 6J Impact

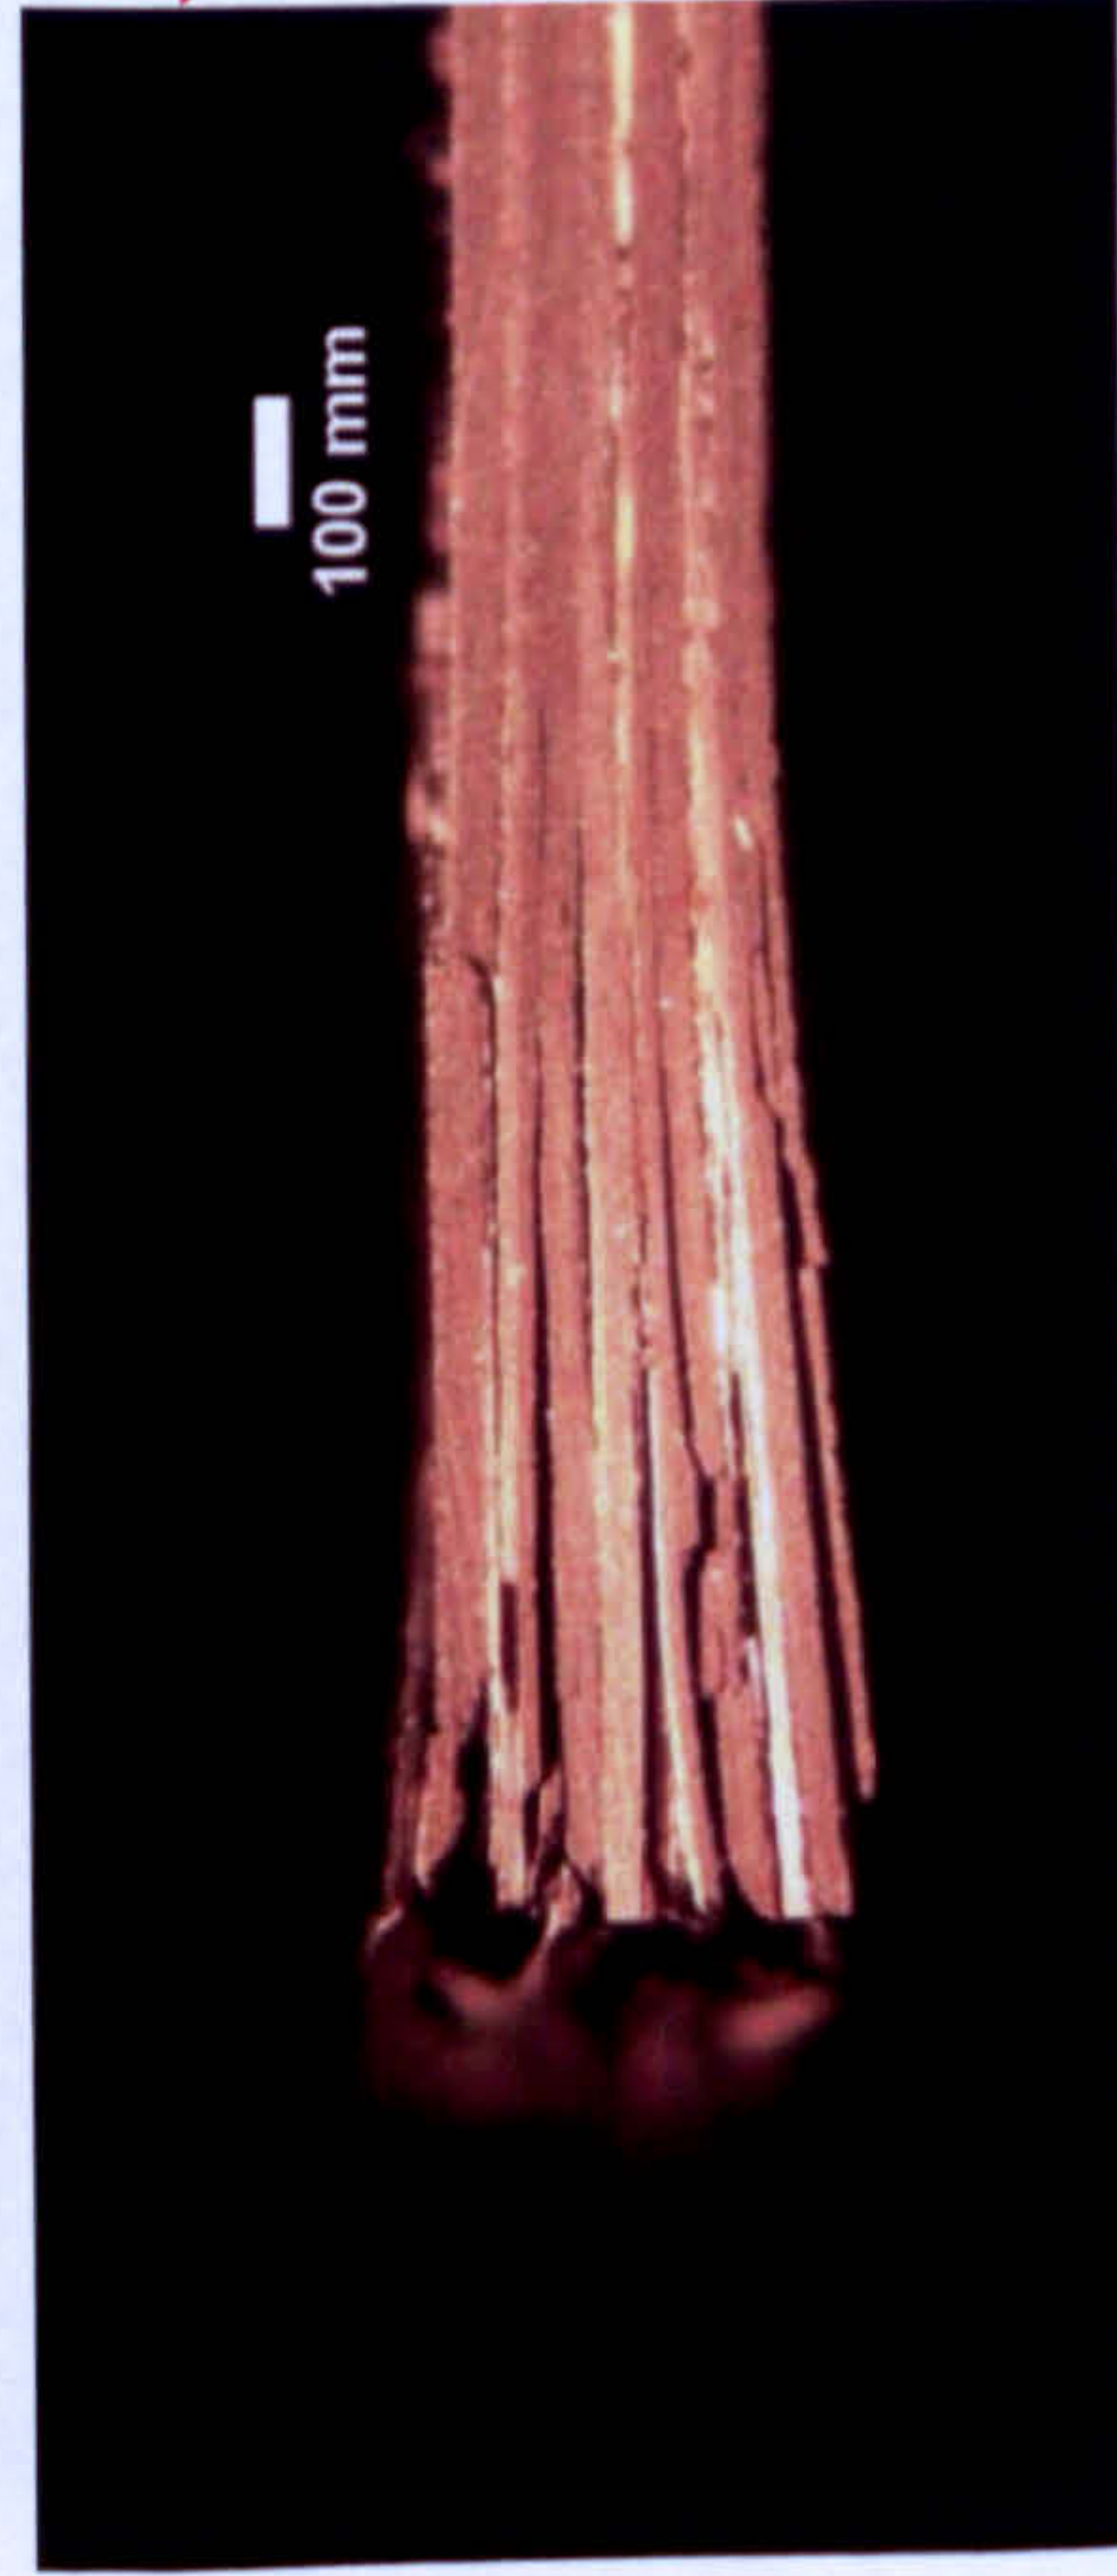
Figure 7-43: Failure Modes of Laminates during CAI Assessment for a) Undamaged: Edge Brooming and b) Damaged: Central Buckle

The failure modes characteristic of each laminate state was observed using ultrasonic assessment in section 4.1. These findings are reinforced in Figure 7-43, where it can be seen that undamaged samples failed by edge brooming and damaged samples failed by central buckling. More specifically, Figure 7-43a) highlights the location of the buckling mode that leads to failure. Here it can be seen that the impact induced delaminations have propagated sufficiently to induce local buckling of the sample and therefore the compression strength is reduced compared to the undamaged laminate as reported in section 3. Figure 7-43b) highlights the location of failure for the undamaged laminate. It can be seen that edge brooming occurs, characterised by the separation of plies at the sample edge due to compressive loading. It was also noted that the healed samples all failed by central buckling which indicated that little or no healing was evident, as reported in section 3.

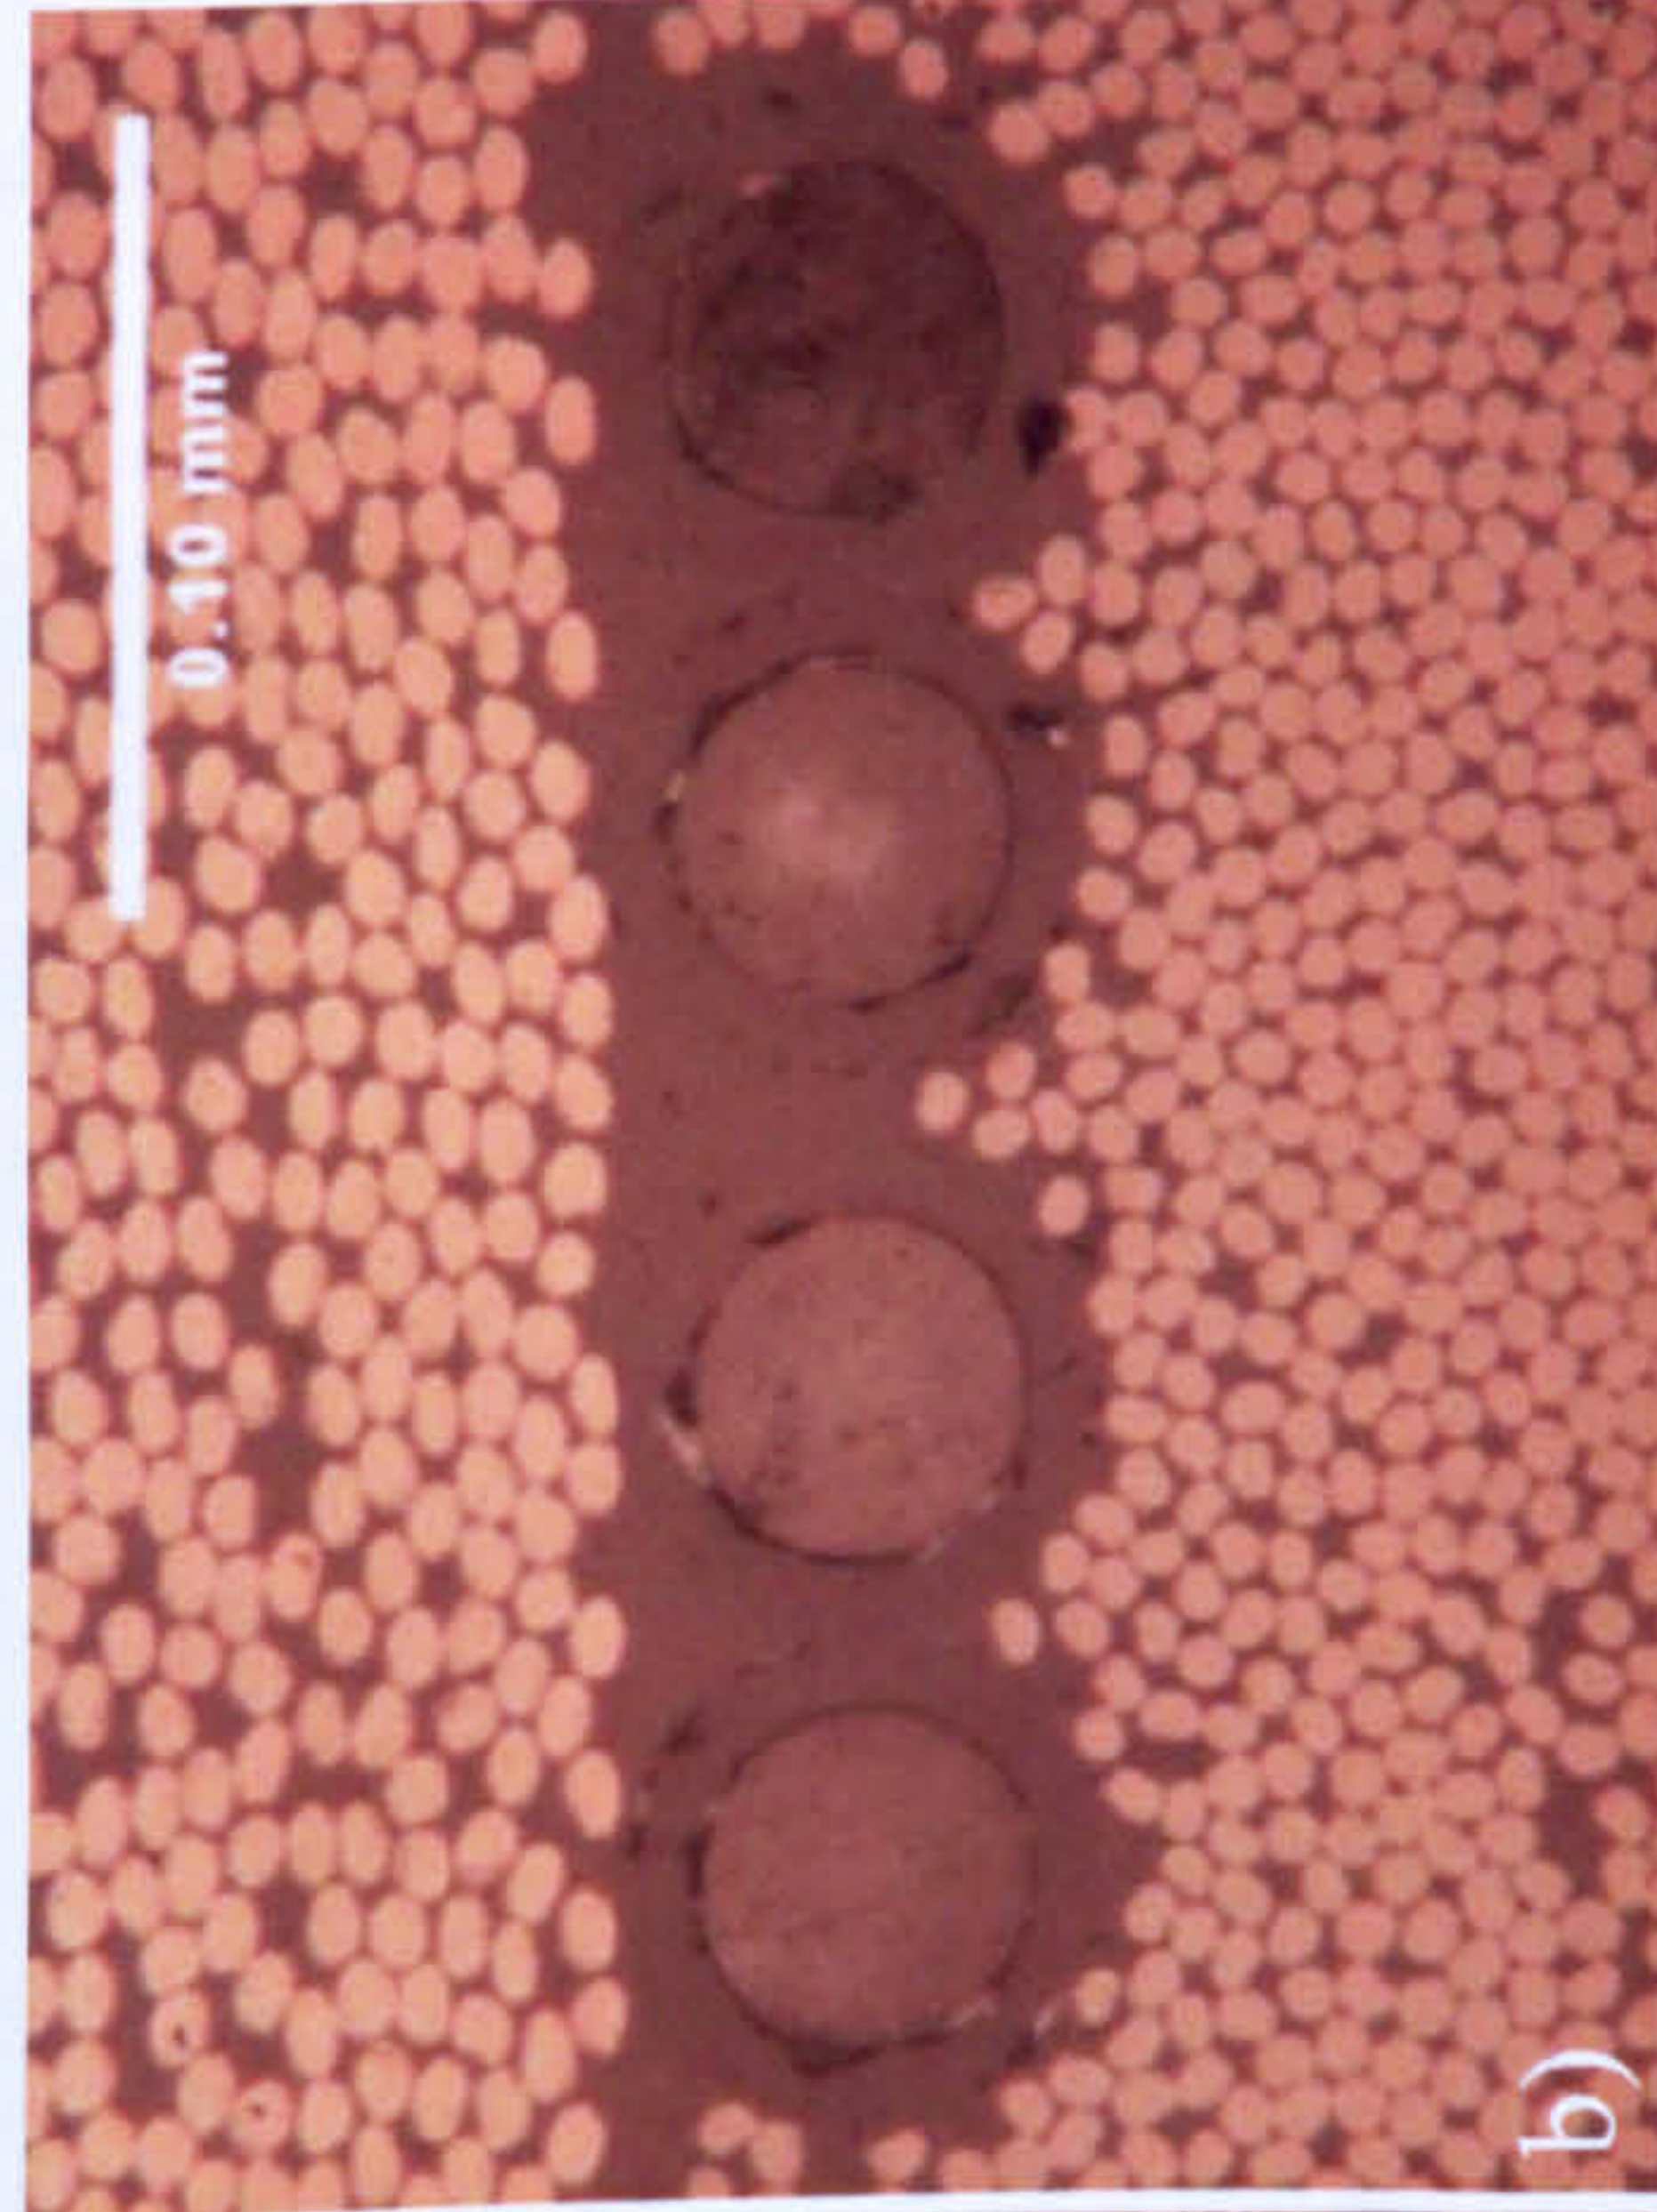
Figure 8-6: HGF at five interfaces showing a) overall HGF distribution and optimal spacing at b) 70 μ m and c) 140 μ m

Figure 8-6 shows the distribution of HGF within the optimised self-healing laminate configuration. Regions of uniformity can be observed for HGF spacings of 70µm (Figure 8-6b) and 140µm (Figure 8-6c). However, Figure 8-6a shows that HGF clumping is present for both 140µm Figure 8-7a),b) and 70µm Figure 8-7c) HGF densities. The cause of this defect can be attributed to an un-optimised manufacturing process which could be easily improved to achieve greater uniformity in HGF distribution. However, it was observed in Chapters 6 and 7 that HGF clumping observed at high HGF volume fractions (V_{HGF}) could be beneficial by increasing the
